**8.3 Report of Comprehensive Facilities Condition Assessment & Space Utilization Survey For Building 115 (CT-8) (November 2010)**

# COMPREHENSIVE FACILITIES CONDITION ASSESSMENT & SPACE UTILIZATION SURVEY

BUILDING 115 (CT-8)  
SAINT ELIZABETHS HOSPITAL  
1100 ALABAMA AVENUE, SE  
WASHINGTON, D.C. 20032

November 1, 2010

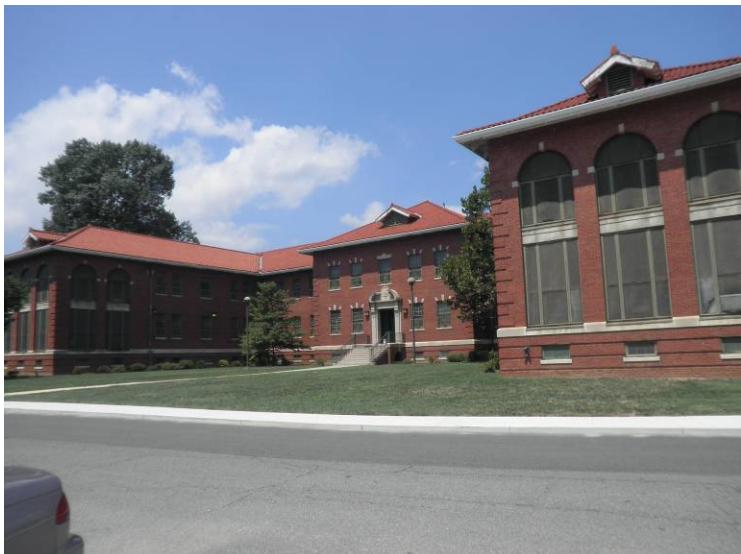
**Photograph No. 1**

The roof is covered with a sloped, hipped roof covered with clay pan tiles (reference Photographs 1, 3 & 9 in Appendix C). The roof was placed at variable field slopes of 7(V):12(H) to 5(V):12(H) and drained to perimeter 6" wide painted copper gutters. Gutters drained to 2" x 4" (nominal) copper downspouts attached to the building facades, which in-turn drained to the below-grade storm water drainage system. The clay pan tiles appeared to be attached over roofing felt to 1" x 2" nominal non-graded wood purlins with surface recessed roofing nails. Purlins are mechanically-attached through the wood roof deck. Table B30-1, Summary of Roof Construction, provides a summary of the roof system.

Front (southeast) elevation

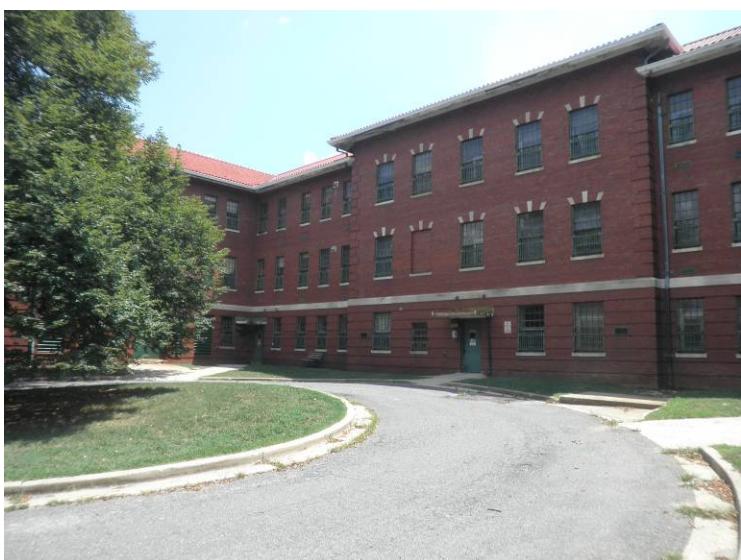
**Photograph No. 3**

Rear (northwest) elevation

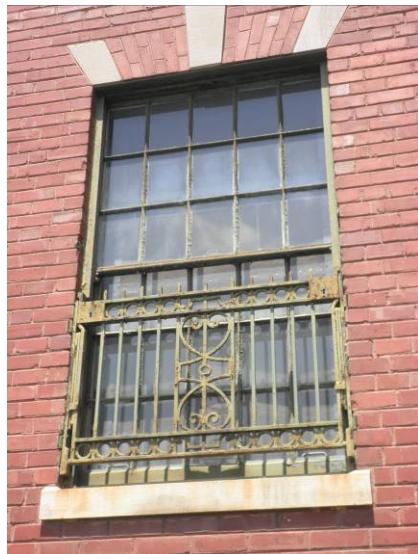
Photograph No. 4

The third principal area of exterior deterioration noted was peeled paint at the steel lintels, wood trim, wood paneling and entrance doors (reference Photographs 4, 5 & 10 in Appendix C). These conditions have resulted in surface corrosion at the steel lintels, and due to the expansion of the corroding metal, cracking of the surrounding mortar, corrosion of the metal entrance doors, and localized, but widespread instances of

Windows are original to the building and in fair structural condition, but poor aesthetic condition (reference Photographs 4 & 5 in Appendix C). We noted widespread instances of peeled paint at the window frames and lintels, localized instances of cracked glazing panels, hardening and separation of perimeter caulking and glazing compound, corrosion of window mullions and gratings, poor seals between operable and fixed portions of the windows, missing (and now covered with plywood) windows at the basement level, and poor operation of the windows. Based upon the extent of deterioration and considering the historic nature of the building, we recommend that the windows be refurbished as part of any change-of-use. Refurbishment should consist of the following general scope:

Typical window

split, detached and rotted wood trim. We have recommended budgeting for near-term replacement of deteriorated wood trim and repainting of the exterior of the building.

- Determine exact condition of each window and required repair / replacement work
- Remove and deconstruct windows
- Remove lead based paint
- Repair structural mortise and tenon joints
- Replace deteriorated components
- Apply epoxy coating
- Apply epoxy filler
- Finish sand
- Replace glazing and sealants
- Finish prime and paint
- Re-install to include replacing perimeter caulking and installing storm windows

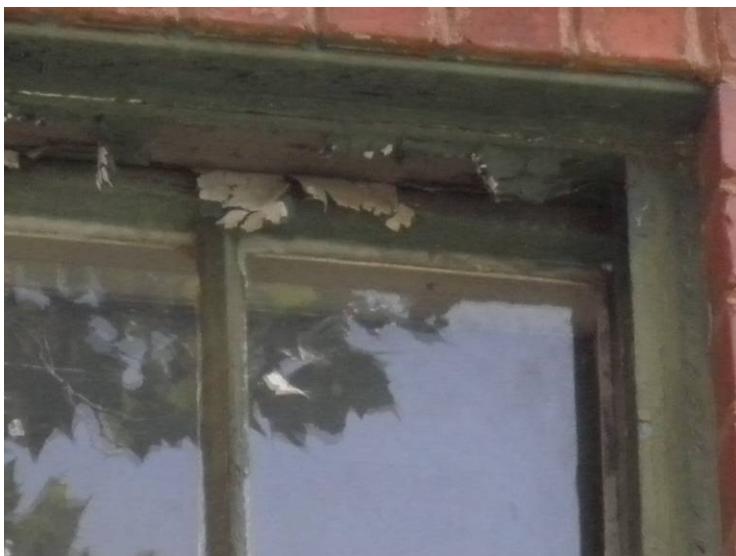
Photograph No. 5

Typical window conditions

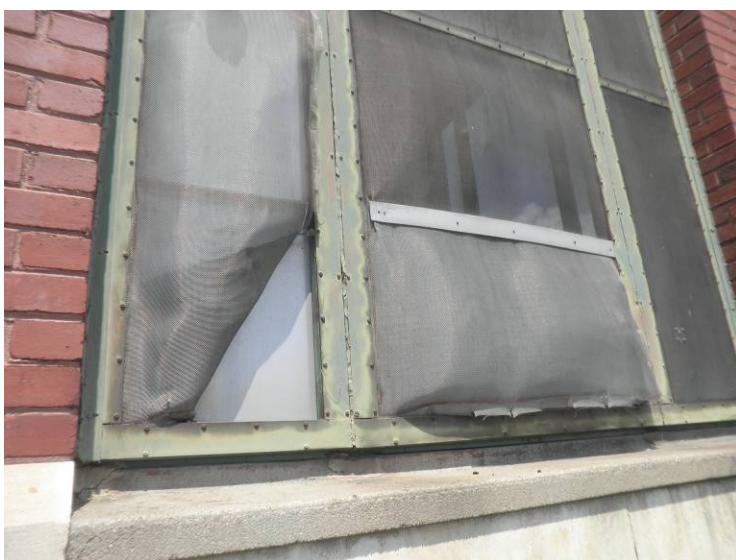
Photograph No. 6

Screens provided at the end porches were in poor condition (reference Photograph 6 in Appendix C). We noted numerous instances of damaged screen sections, expansive sectional corrosion of structural bars and displacement of covers. Due to the extent of deterioration at their supporting structure, we have assumed that the appropriate regulatory parties will allow removal of the screens and replacement with a new comparative system.

Typical porch screen conditions

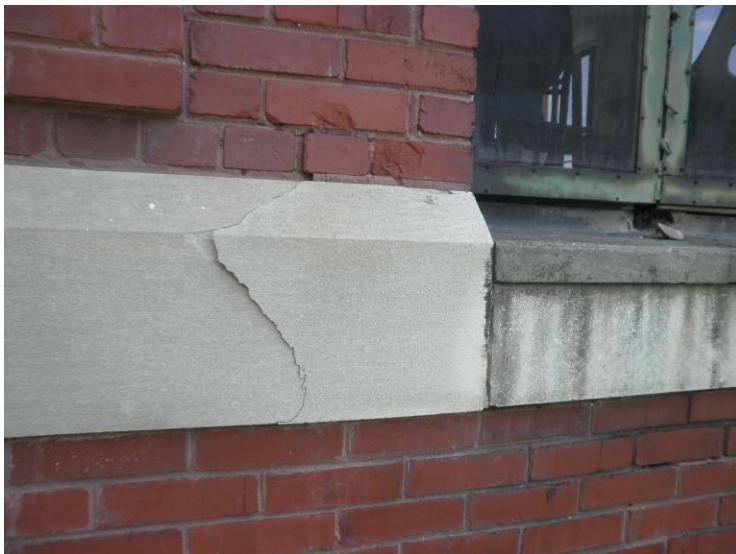
**Photograph No. 7**

The first and primary area of concern noted at the exterior wall system was cracking, erosion and separation of the cementitious mortar provided between the cast stone panels (reference Photographs 7 & 8 in Appendix C). At the lower level cast stone panels, this had resulted in localized displacement of the panels and longitudinal and traverse cracks resulting from freeze-thaw cycles. We have recommended budgeting for the near-term replacement of mortar at the cast stone panels, repairs to damaged panels and cleaning of rust stains caused by the steel window grilles.

Façade cast stone belt course conditions

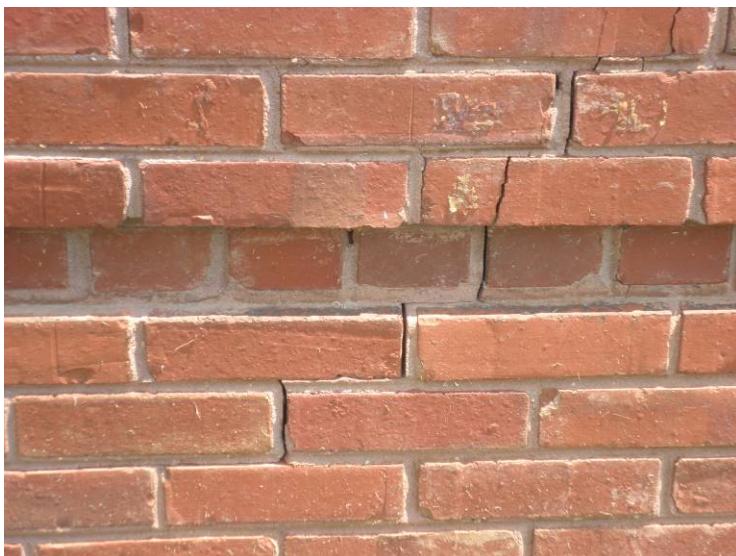
**Photograph No. 8**

Façade brick condition detail

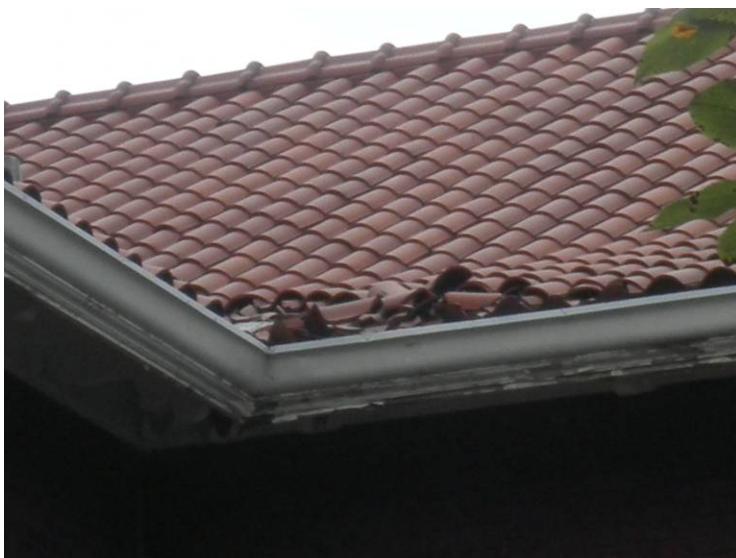
**Photograph No. 9**

Roof detail

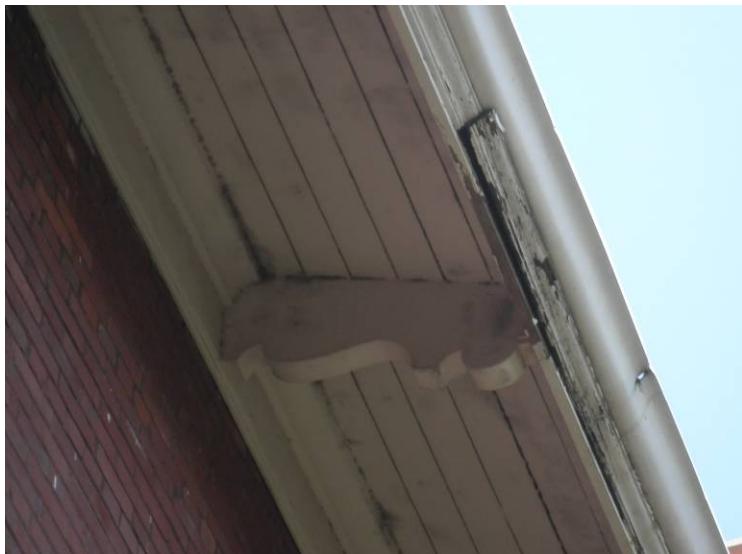
**Photograph No. 10**

Roof soffit detail

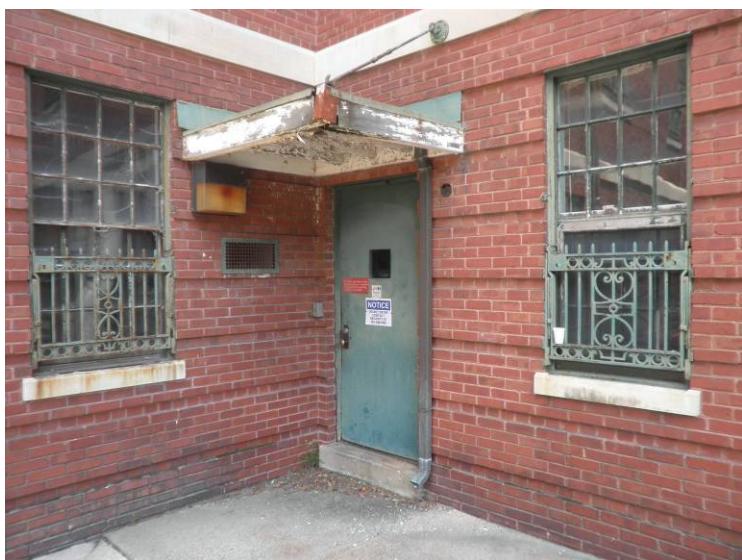
**Photograph No. 11**

Doors appeared to be in generally fair to poor condition with base level frame and door corrosion noted throughout (reference Photograph 11 in Appendix C). We have recommended budgeting for replacement of doors and associated frames.

Rear entrance canopy

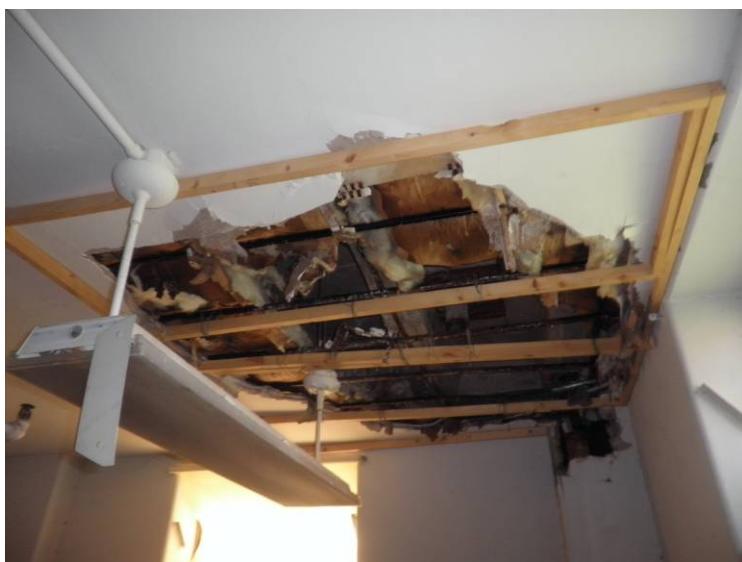
**Photograph No. 17**

Water damaged plaster ceiling in the west wing of the basement
