8.3 Report of Comprehensive Facilities Condition Assessment & Space Utilization Survey For Building 116 (CT-7) (November 2010)

COMPREHENSIVE FACILITIES CONDITION ASSESSMENT & SPACE UTILIZATION SURVEY

BUILDING 116 (GT7)
SAINT ELIZABETHS HOSPITAL
1100 ALABAMA AVENUE, SE
WASHINGTON, D.C 20032

PUBLISHED NOVEMBER 2010, BY
DISTRICT OF COLUMBIA DEPARTMENT OF REAL ESTATE SERVICES
ROBIN-EVE JASPER, DIRECTOR
GERICK T. SMITH, DEPUTY DIRECTOR OF CONSTRUCTION DIVISION

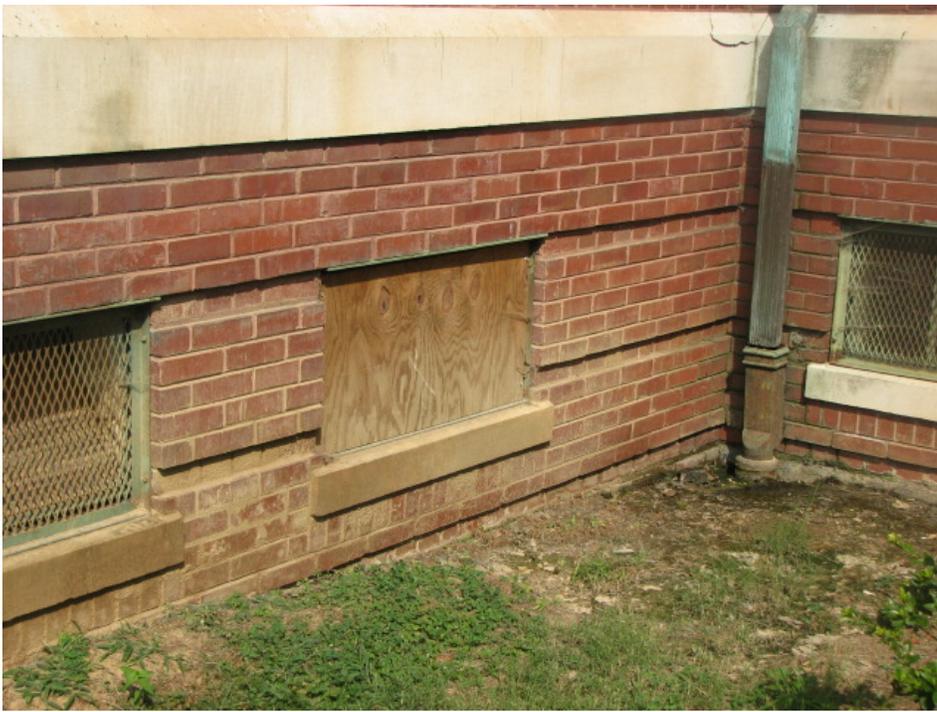
Photograph Number 1

Missing window at basement

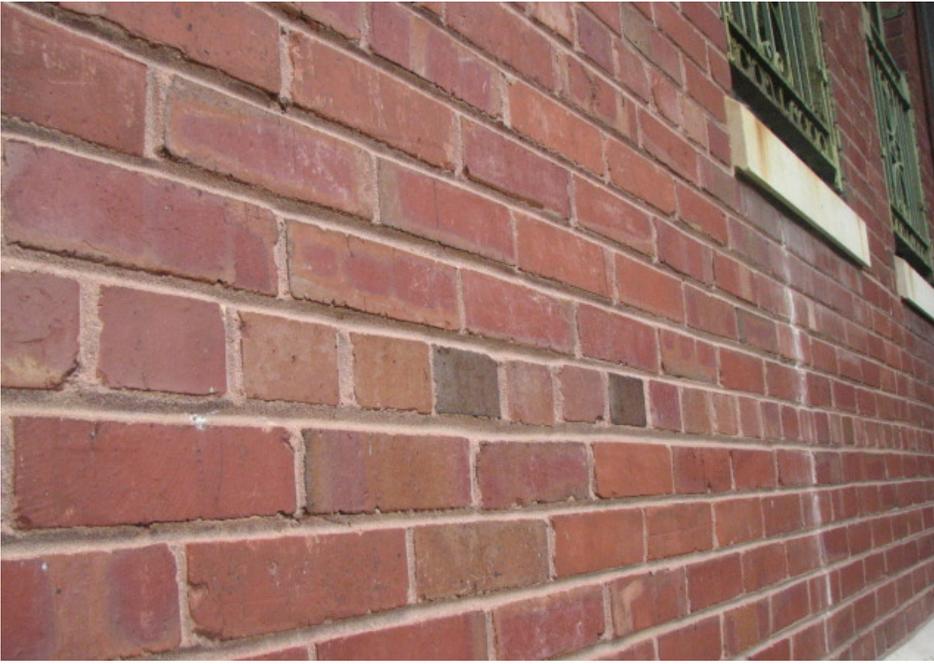
Photograph Number 7

Brick and mortar in good condition
(typical)

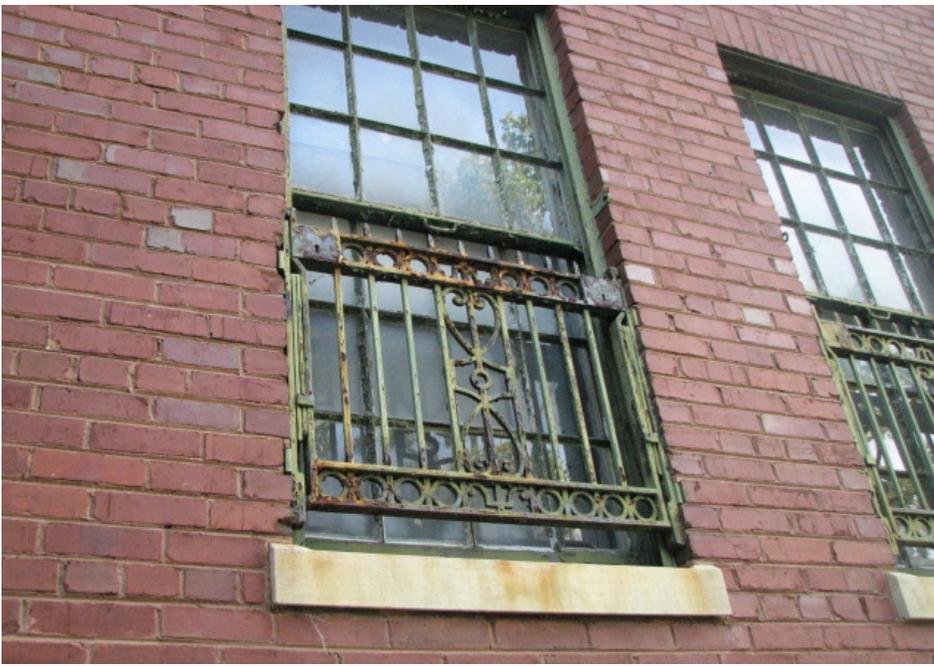
Photograph Number 20

Corrosion of grating at window system

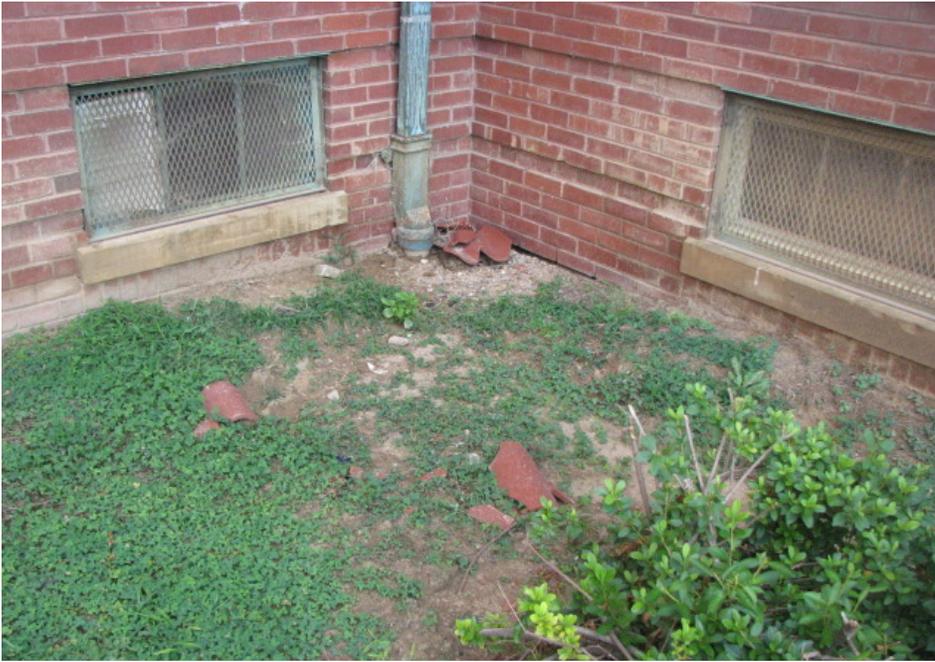
Photograph Number 22

Broken roof tiles at grade

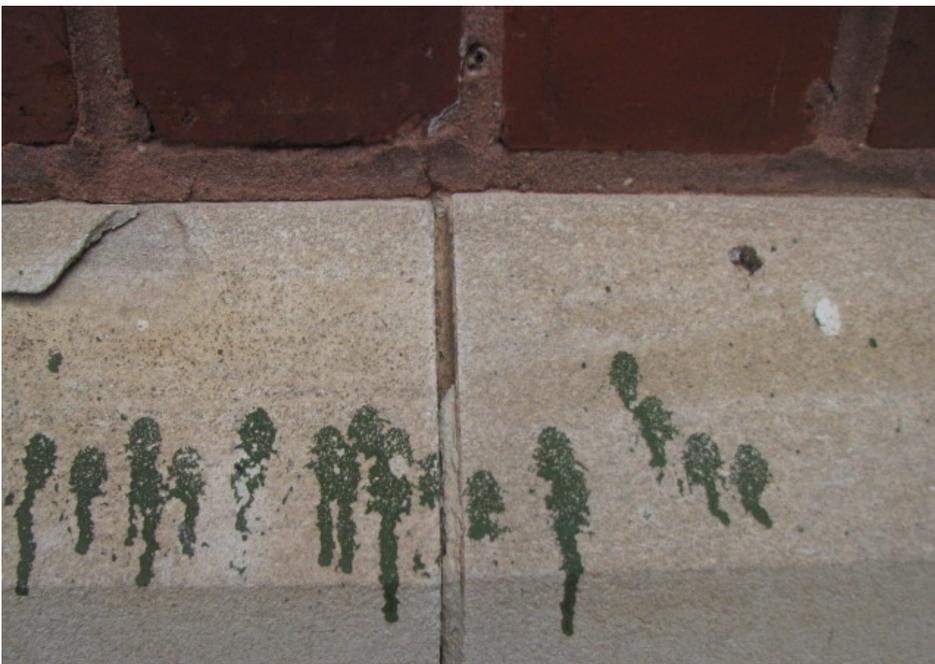
Photograph Number 26

The first and primary area of concern noted at the exterior wall system was severe cracking, erosion and separation of the cementitious mortar provided between the cast stone panels (reference Photographs 26 through 27 in Appendix C). At the lower level panels this had resulted in localized displacement of the panels and longitudinal and traverse cracks resulting from freeze-thaw cycles. We have recommended budgeting for the near-term replacement of mortar at the cast stone panels and for cleaning of rust stains.

Failed mortar at cast stone band

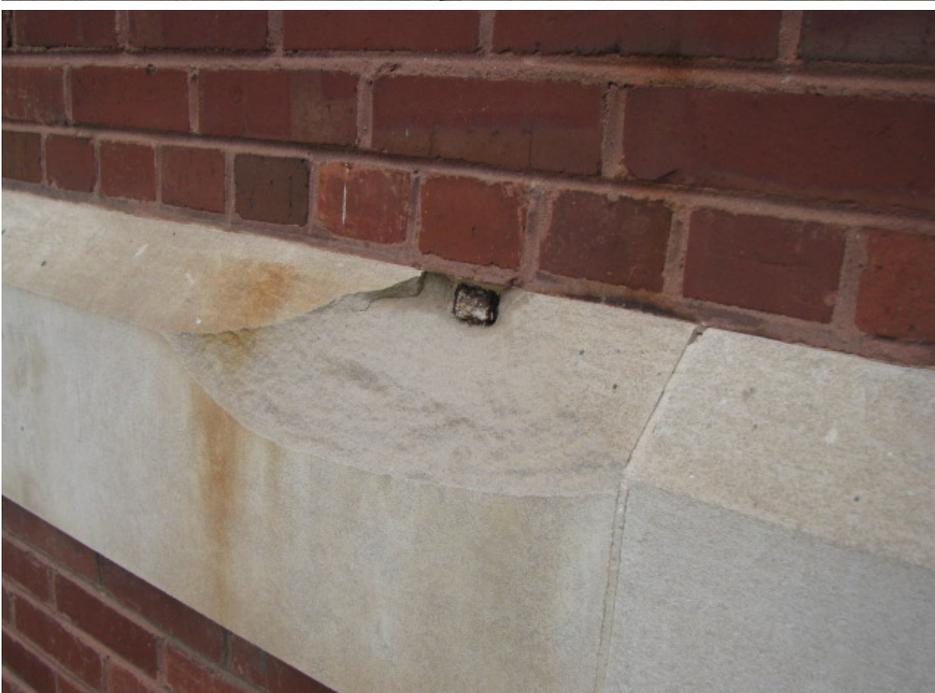
Photograph Number 27

Steel fastener at cast stone band

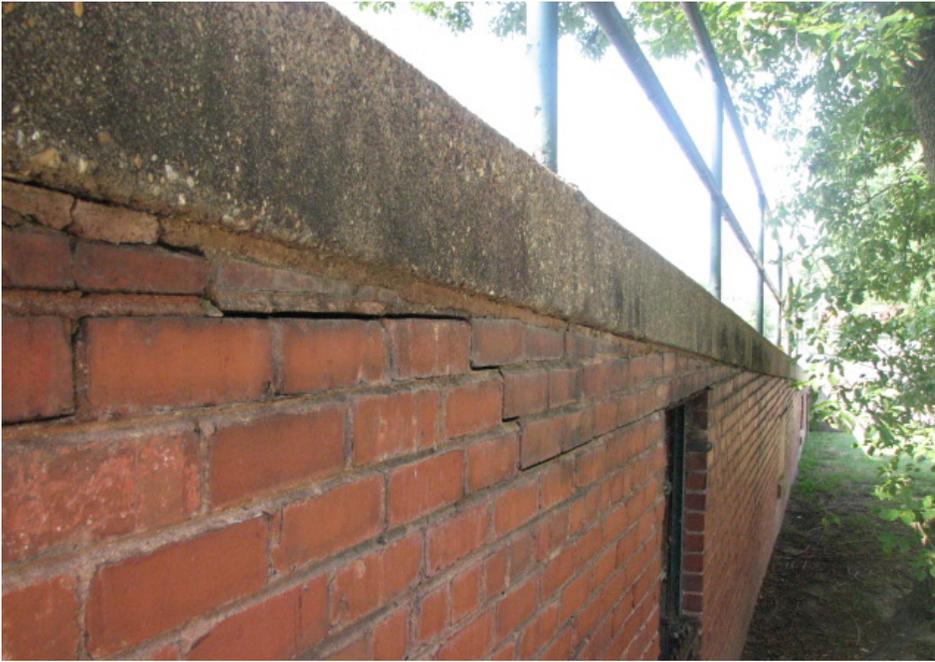
Photograph Number 28

Stepped cracks at outer wall of utility tunnel

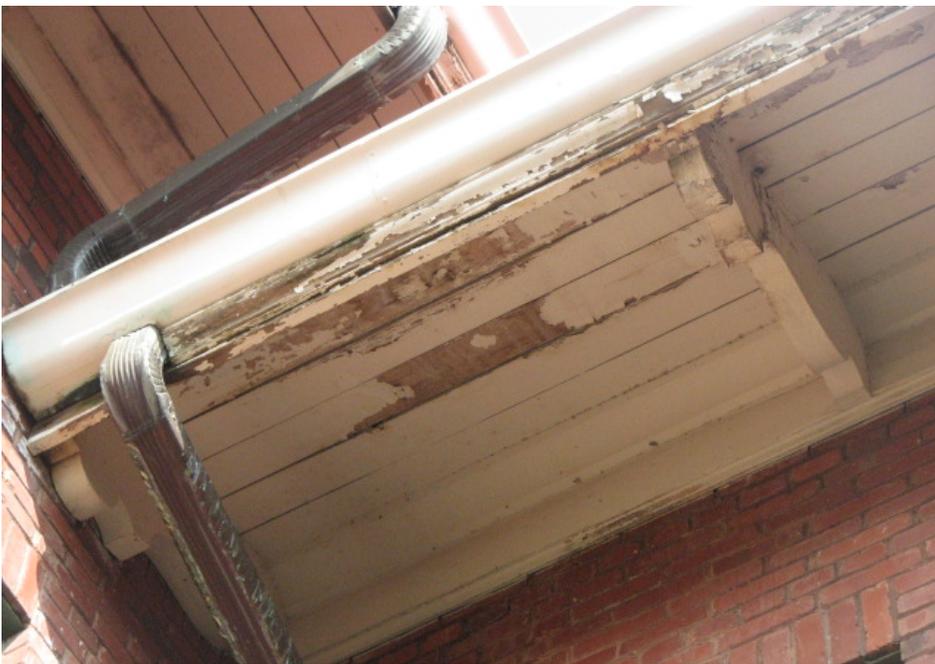
Photograph Number 29

Peeled paint and rotted boards at soffit overhang

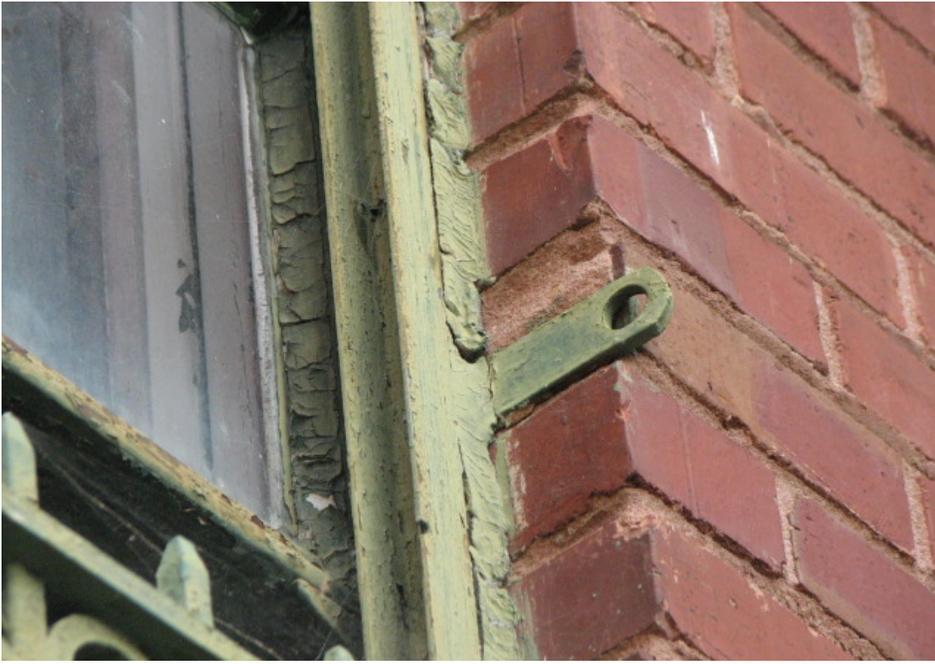
Photograph Number 34

Failed urethane caulk at outer perimeter of window system

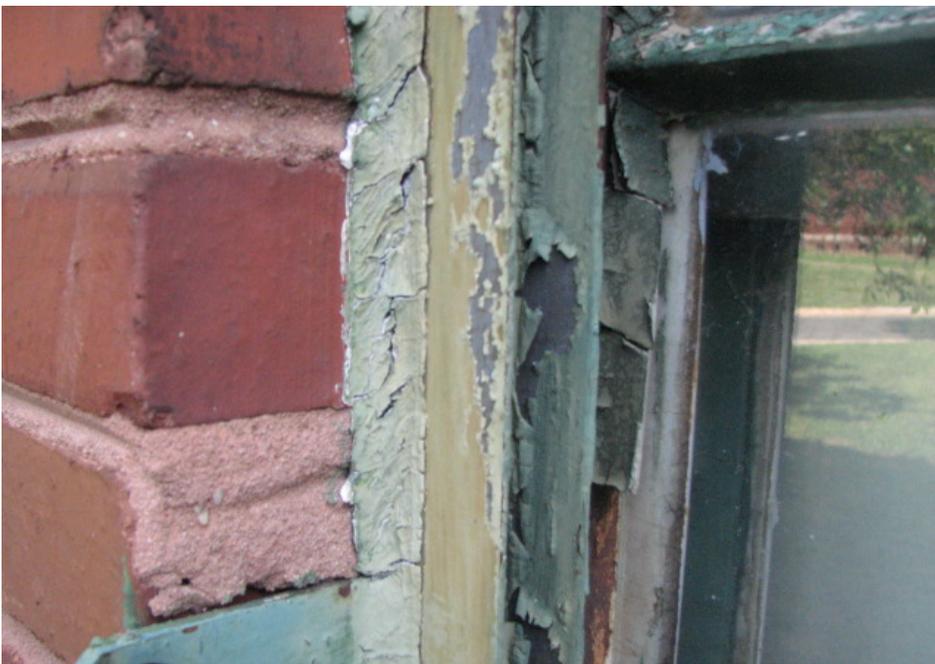
Photograph Number 35

Failed caulk at window

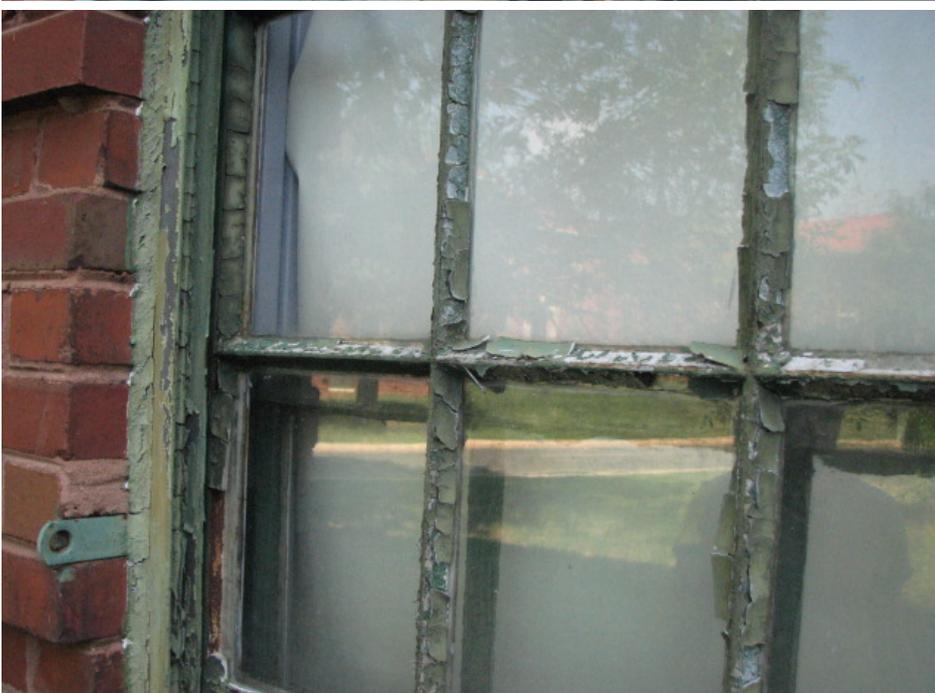
Photograph Number 36

Peeled paint at window

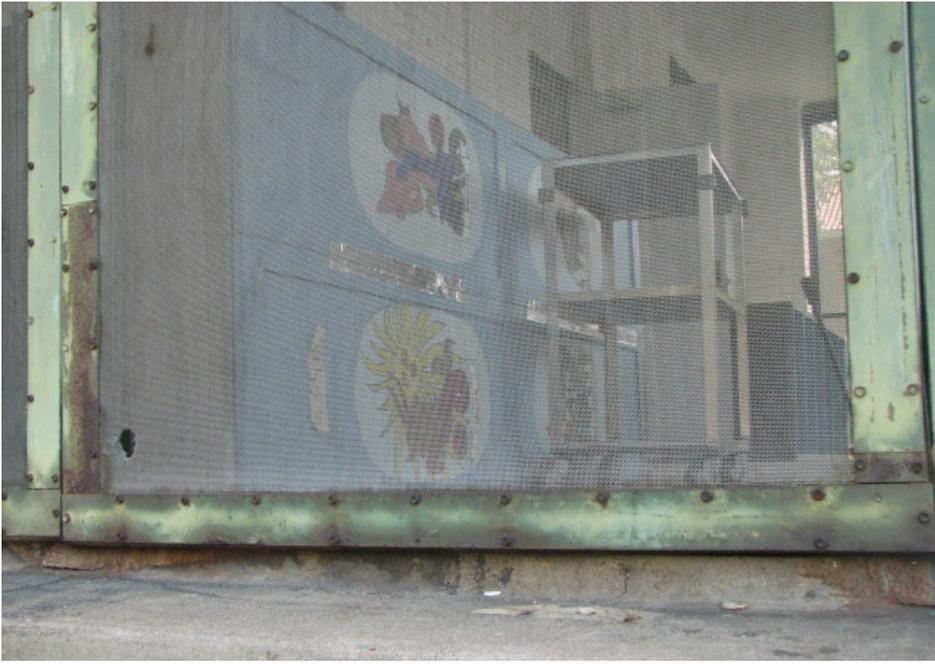
Photograph Number 37

General deterioration of porch screens

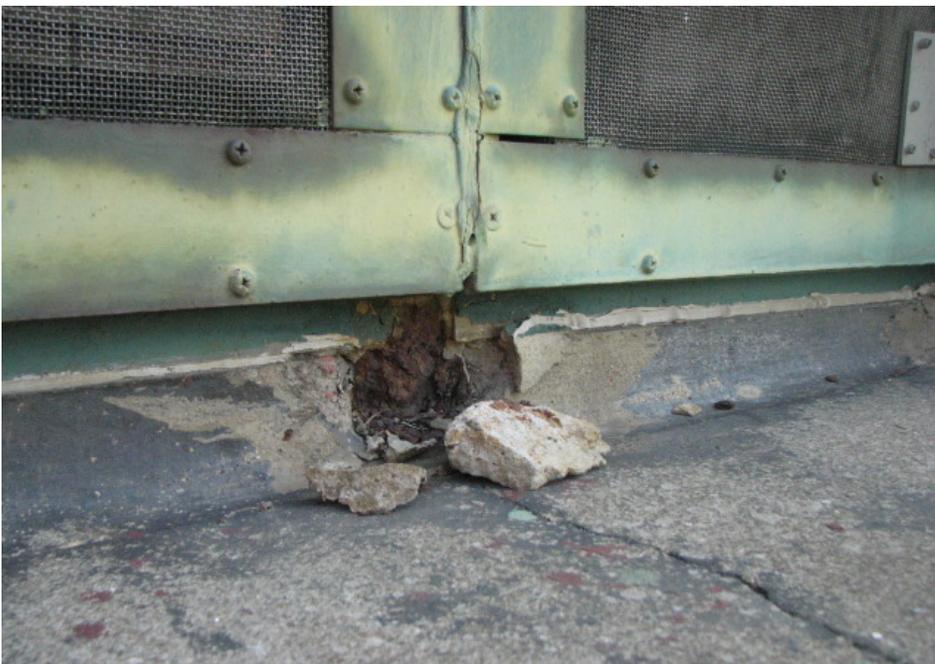
Photograph Number 38

Expansive corrosion of framing member at porch screens

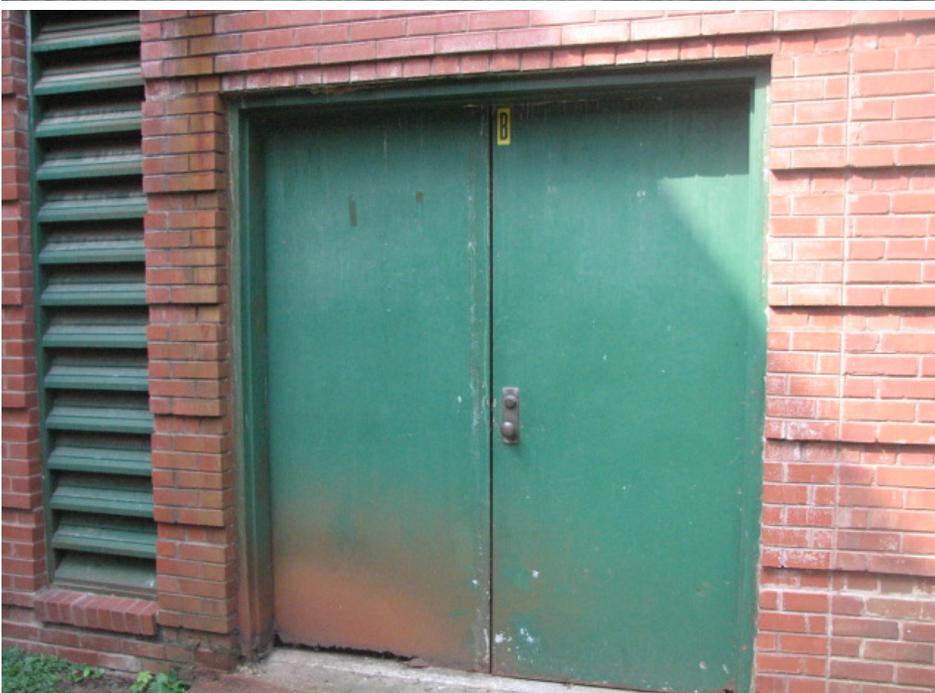
Photograph Number 39

Corrosion of steel panel doors at mechanical room

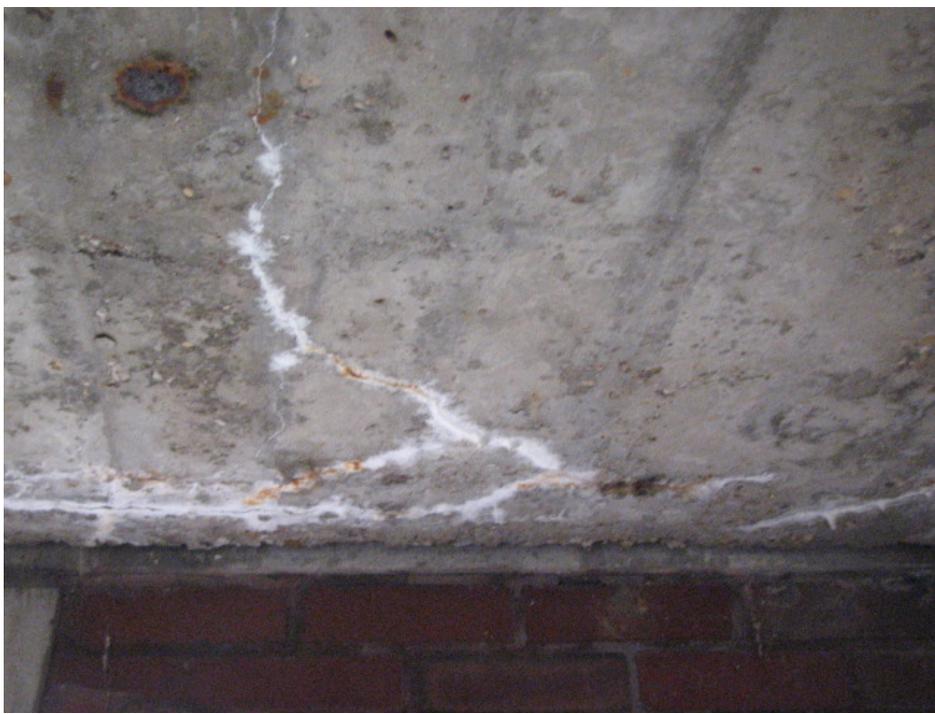
Photograph Number 48

Failed concrete at underside of entrance steps

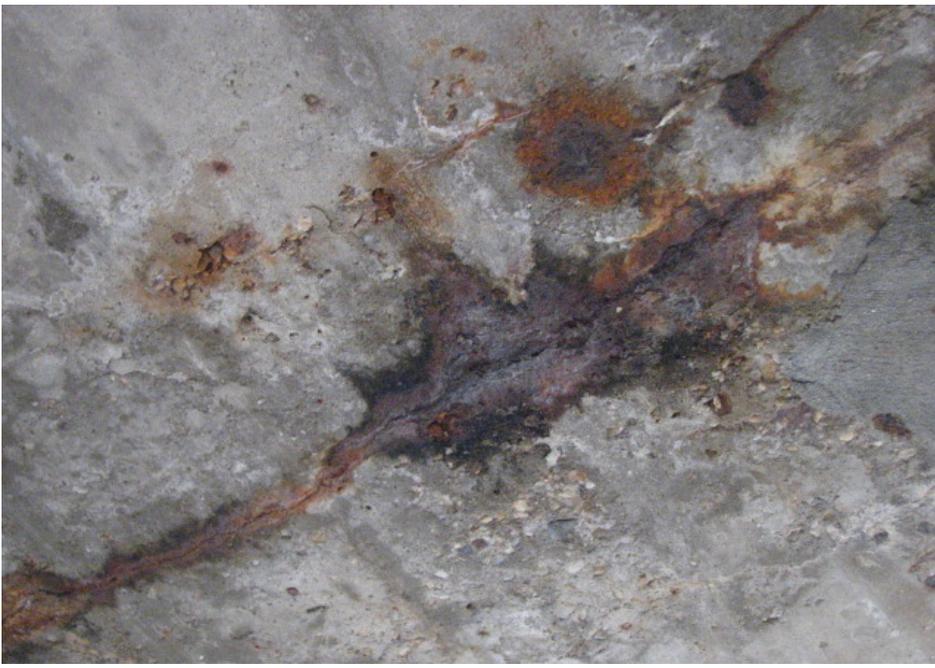
Photograph Number 49

Corroded reinforcing steel at underside of entrance steps

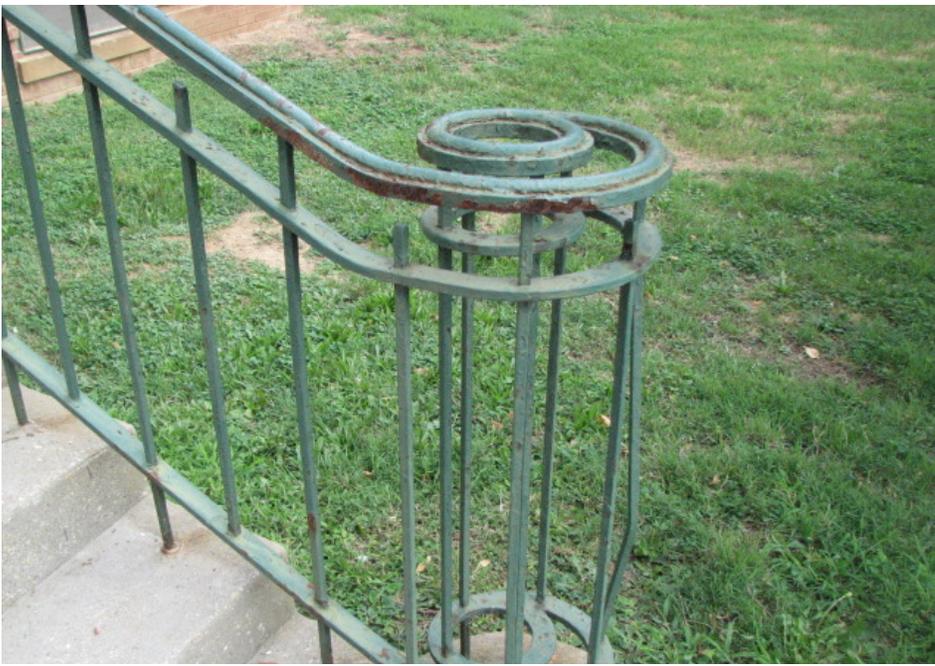
Photograph Number 50

Peeled paint and corrosion at railings to entrance steps
