**8.3 Report of Comprehensive Facilities Condition Assessment & Space Utilization Survey For Building 115 (CT-8) (November 2010)**

# COMPREHENSIVE FACILITIES CONDITION ASSESSMENT & SPACE UTILIZATION SURVEY

BUILDING 115 (CT-8)  
SAINT ELIZABETHS HOSPITAL  
1100 ALABAMA AVENUE, SE  
WASHINGTON, D.C. 20032

November 1, 2010

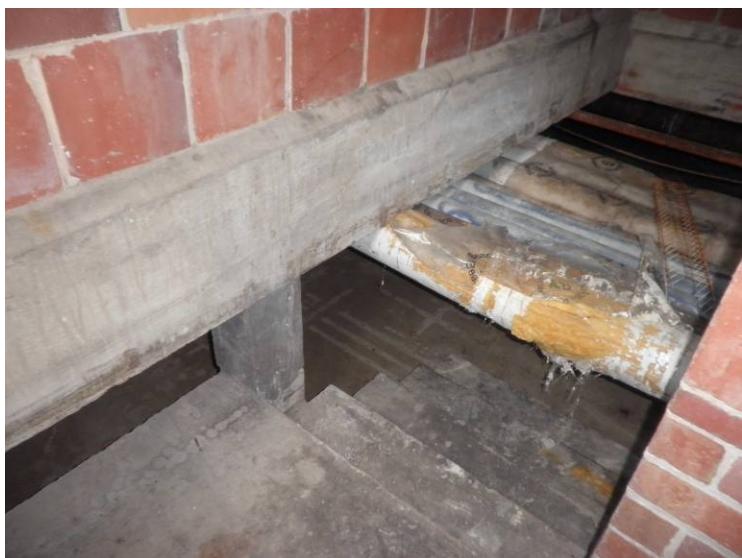
**Photograph No. 12**

The steam piping system is welded black steel pipe. Most steam piping is insulated except at equipment connections and steam traps. Most of this older steam piping insulation is believed to contain asbestos (reference Photograph 12 in Appendix C).

Utility tunnel below the basement level

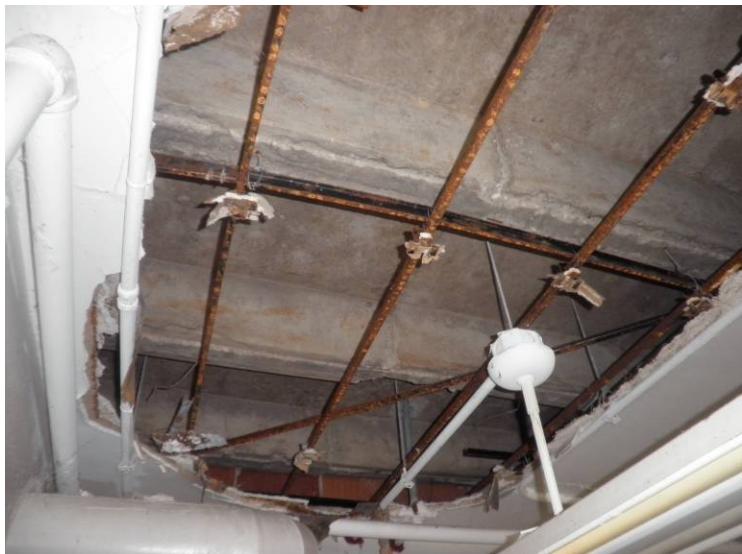
**Photograph No. 13**

Upper floors including the floor at the attic space consisted of 8½" deep cast-in-place concrete joists spaced at 24" on-center and supported on the concrete frame superstructure, the interior load-bearing terra cotta walls or exterior masonry walls (reference Photograph 13 in Appendix C). Floor joists were covered with a total of 5" thick cast-in-place concrete flat panel slabs and topping material bearing onto the load-bearing masonry. Slab edges were thickened to 24" at the connection with the exterior wall system. The floor to floor heights are 10'-6" basement to first floor, 11'-8" first floor to second floor and 15'-0" second floor to the top of the attic's structural deck.

The typical concrete superstructure viewed through a ceiling opening

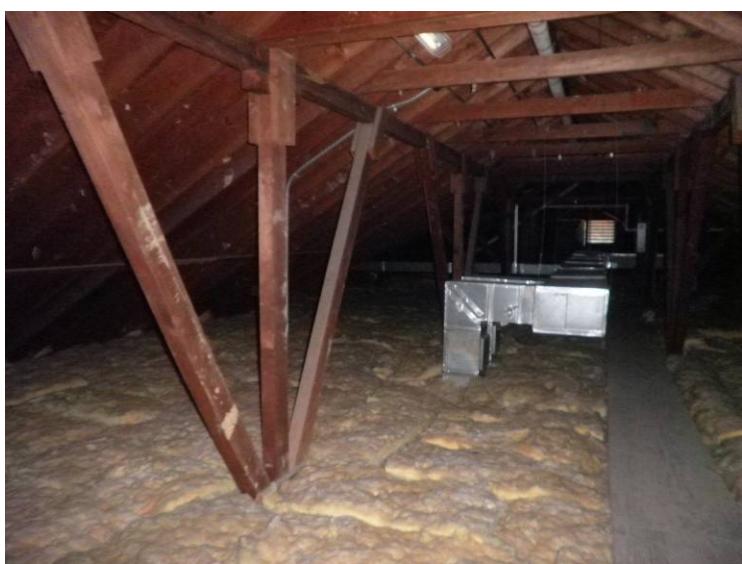
**Photograph No. 14**

The structural system utilized to support the sloped hip roof system consisted of site-assembled wood rafters supported on the concrete superstructure (reference Photograph 14 in Appendix C). The structure consisted of 2" x 10" wood rafters placed at 16" on-center and bearing on 4" x 6" juncture beams. Support at the juncture beams and mid-span support of the rafters was provided by 6" x 4" king posts. The roof deck consisted of 1" x 6" wood tongue and groove (T&G) decking boards.

Roofing framing viewed in attic

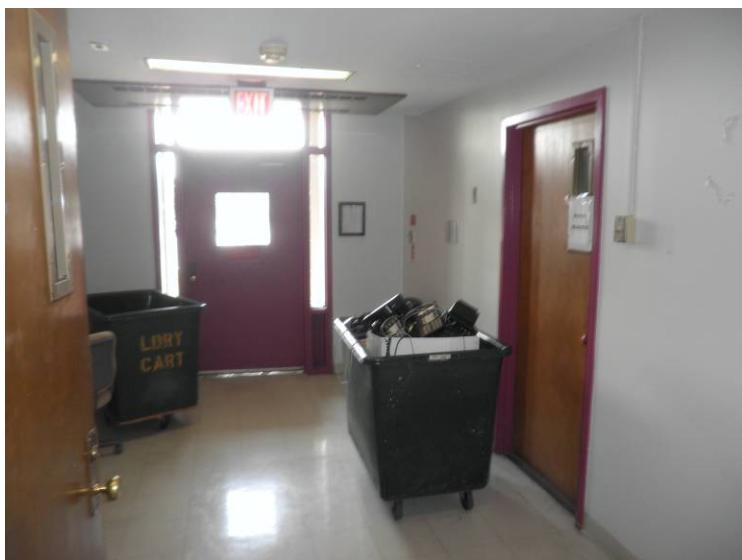
**Photograph No. 18**

Main entrance vestibule at first floor

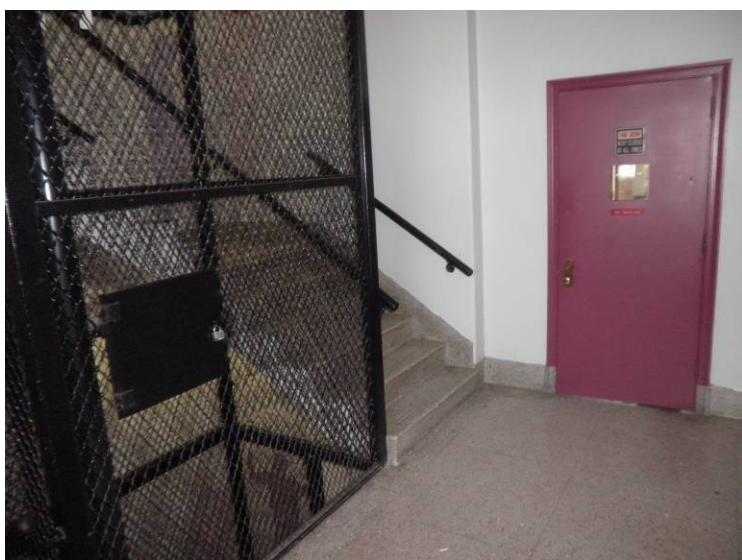
**Photograph No. 24**

The building is provided with exiting through two stairwells located along the central corridors, with one stair leading to directly to the exterior at the basement level, rear elevation and the other leading to the central corridor adjacent to the main entrance vestibule (reference Photographs 18, 24 & 29 in Appendix C). Stairs are enclosed in two-hour rated protected walls. Exit doors had a clear opening width of a minimum of 33" per leaf, although utilizing cylindrical hardware. Illuminated exit signs with battery backup are provided at each exit and at appropriate locations along the path of egress.

Typical stair landing

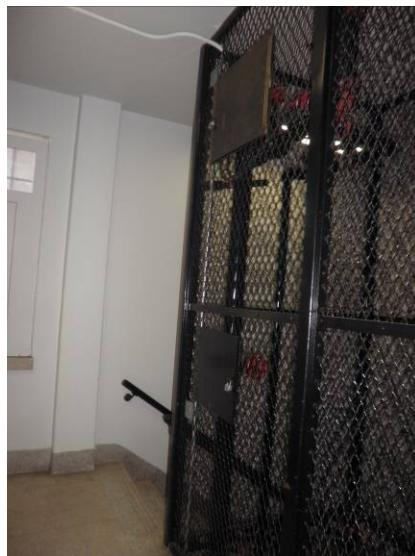
**Photograph No. 29**

The laundry rooms and a limited number of storage closets and utility rooms on each floor were provided with an automatic fire suppression sprinkler system, with other areas of the building not protected by a fire sprinkler system. Standpipes with hose connections were provided in the stairwells, enclosed by locked mesh enclosures (reference Photographs 24 & 29 in Appendix C). The fire suppression system is maintained by utility water pressure, without use of a fire pump. Handheld fire extinguishers, located in wall cabinets, were provided in the central hallway on each floor.

Fire protection standpipe riser enclosed in the stairwells

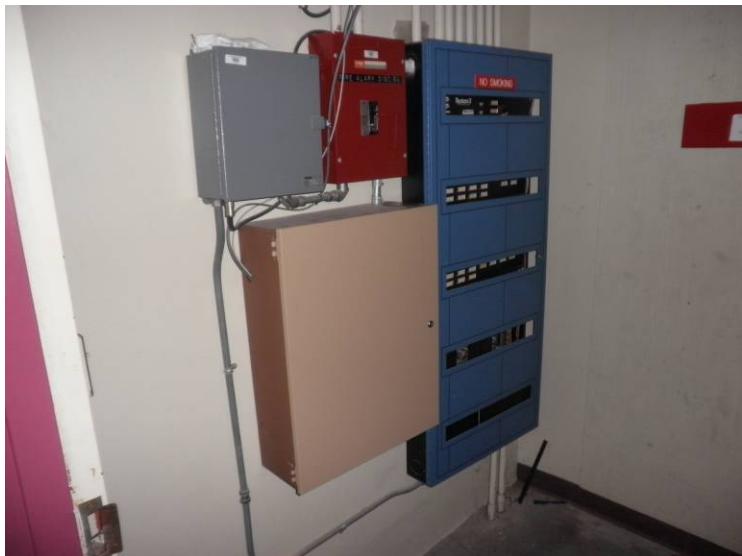
Photograph No. 31

The building is protected by a manual hard-wired, conventional fire alarm system installed in circa 1990 and manufactured by Cerberus Pyrotronics (reference Photograph 31 in Appendix C). The fire alarm control panel (FACP) is located at the basement level. The fire alarm system monitors manual pull stations, smoke and heat detectors and fire sprinkler flow switches. The FACP drives audible-only alarm devices located in the corridors and large spaces, providing only local alarm. No external connection or supervision is provided.

Fire alarm control panel located in the basement

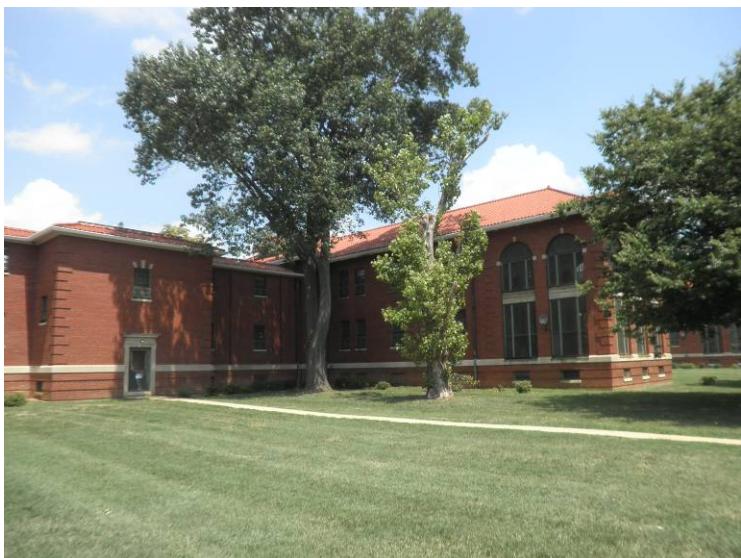
**Photograph No. 35**

Site landscaping and sidewalk at the building's southwest elevation

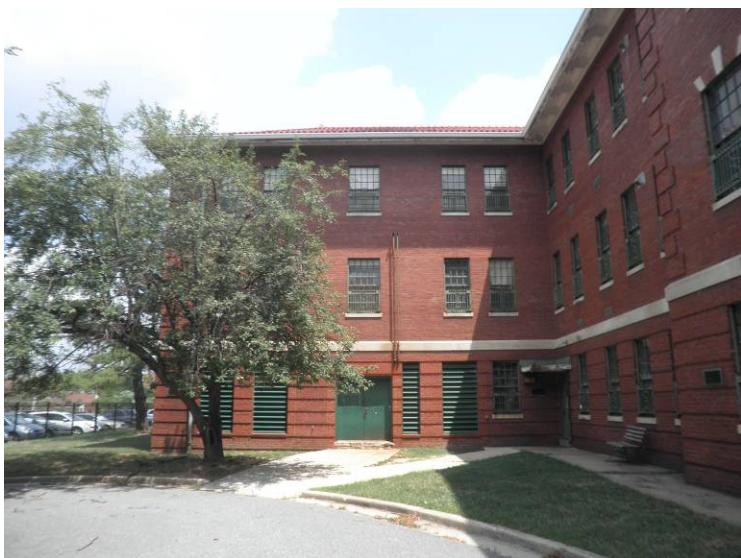
**Photograph No. 36**

The concrete pavement provided at the rear service doors was in fair condition, with limited instances of longitudinal and traverse sectional cracks noted and areas of concrete detachment and surface deterioration (reference Photograph 36 in Appendix C). We have recommended that the pavement be repaired and maintenance for future basement service access.

Site landscaping and inaccessible drive at the rear of the building

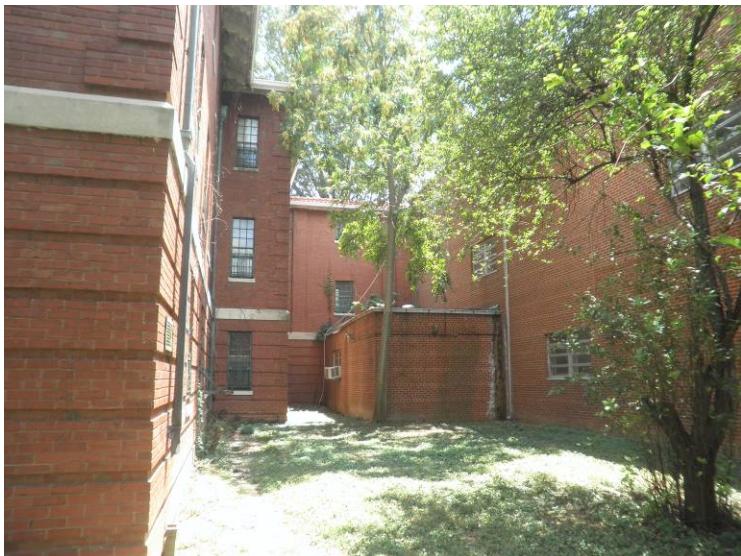
**Photograph No. 37**

Site landscaping at the west side of the Property

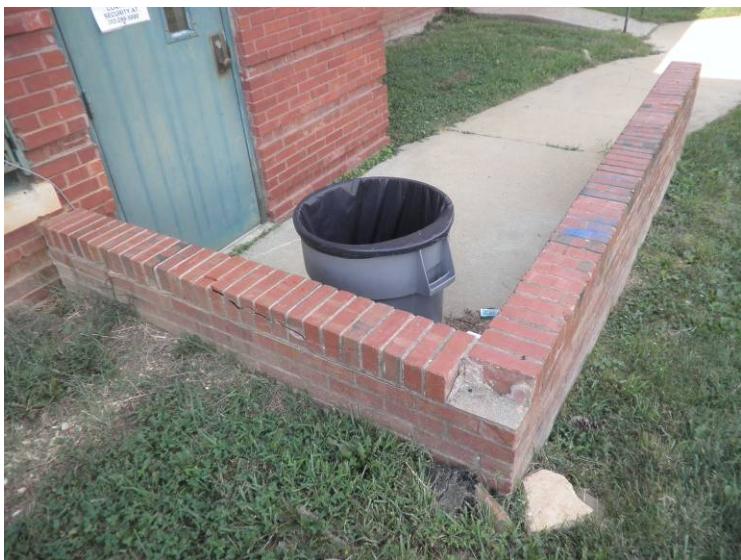
**Photograph No. 38**

Brick retaining wall at the northeast side of the Property
