8.3 Report of Comprehensive Facilities Condition Assessment & Space Utilization Survey For Building 116 (CT-7) (November 2010)

COMPREHENSIVE FACILITIES CONDITION ASSESSMENT & SPACE UTILIZATION SURVEY

BUILDING 116 (GT7)
SAINT ELIZABETHS HOSPITAL
1100 ALABAMA AVENUE, SE
WASHINGTON, D.C 20032

PUBLISHED NOVEMBER 2010, BY
DISTRICT OF COLUMBIA DEPARTMENT OF REAL ESTATE SERVICES
ROBIN-EVE JASPER, DIRECTOR
GERICK T. SMITH, DEPUTY DIRECTOR OF CONSTRUCTION DIVISION

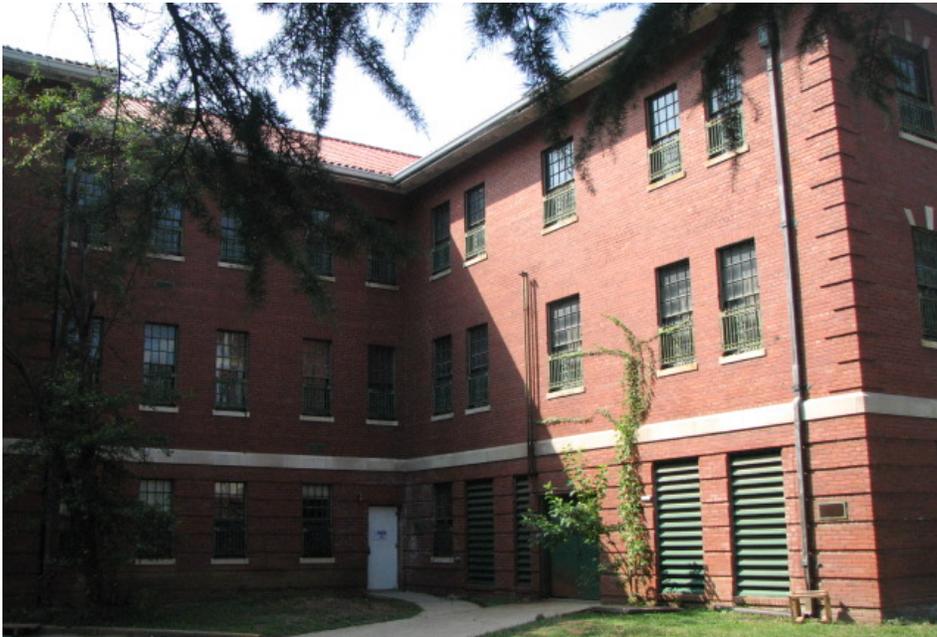
Photograph Number 2

Rear elevation

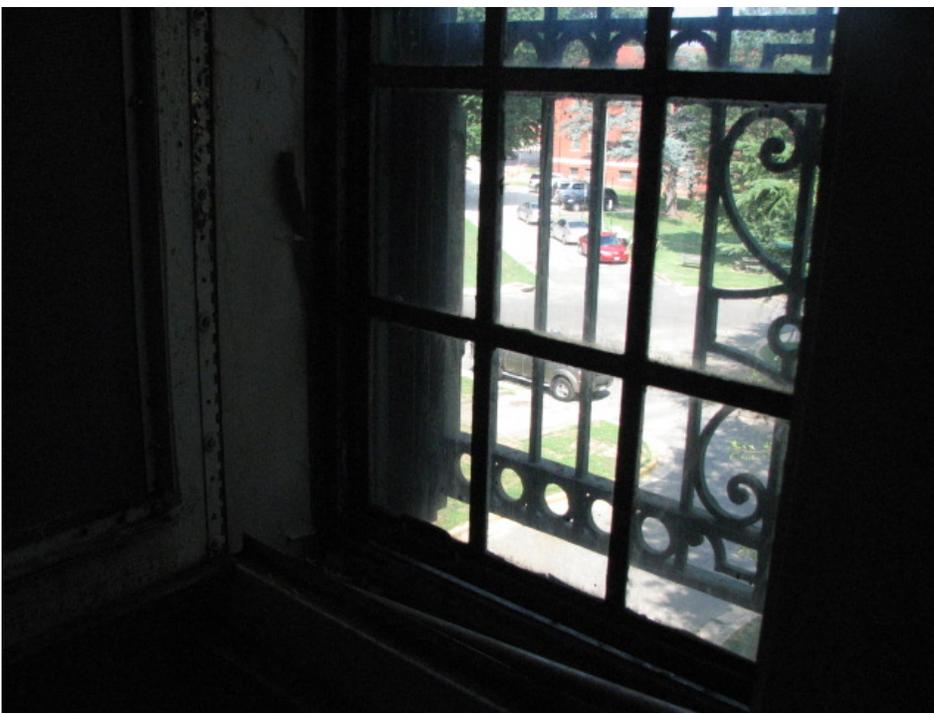
Photograph Number 21

Interior view of window system

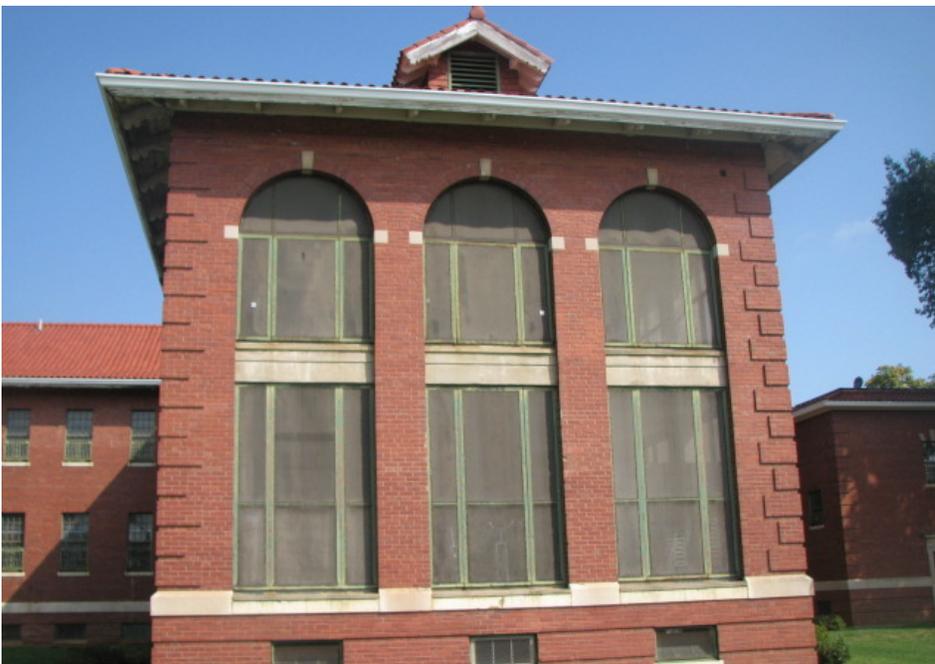
Photograph Number 23

Porch screens

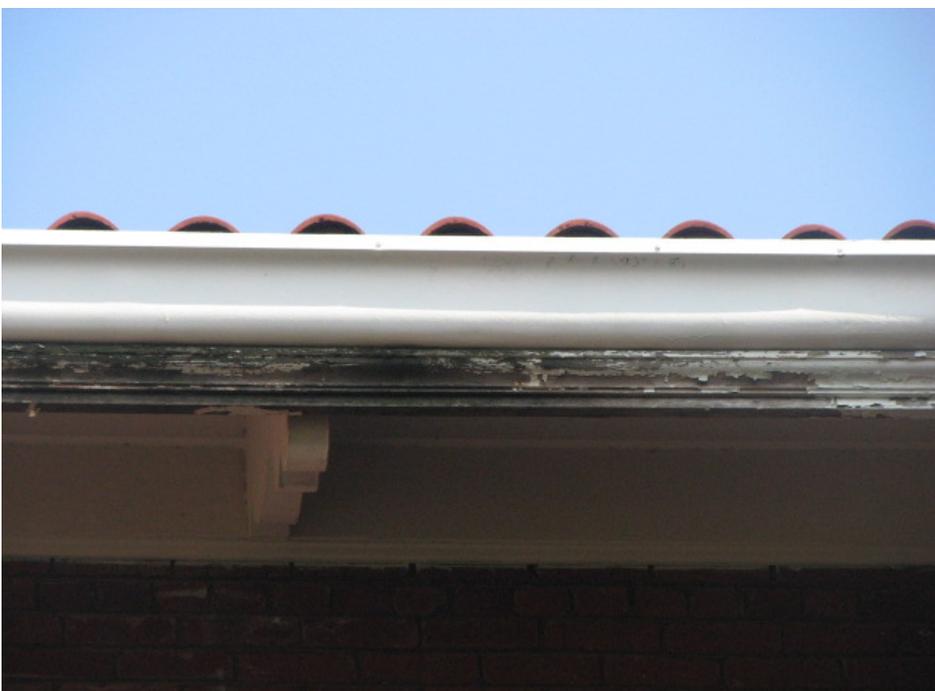
Photograph Number 30

Peeled paint at soffit trim

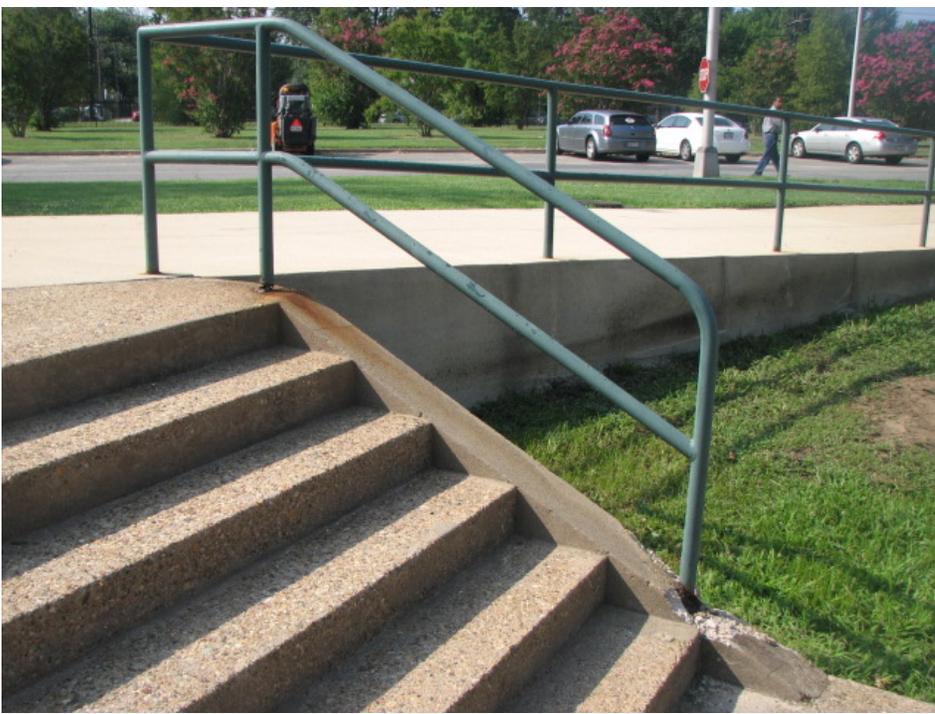
Photograph Number 51

Concrete steps

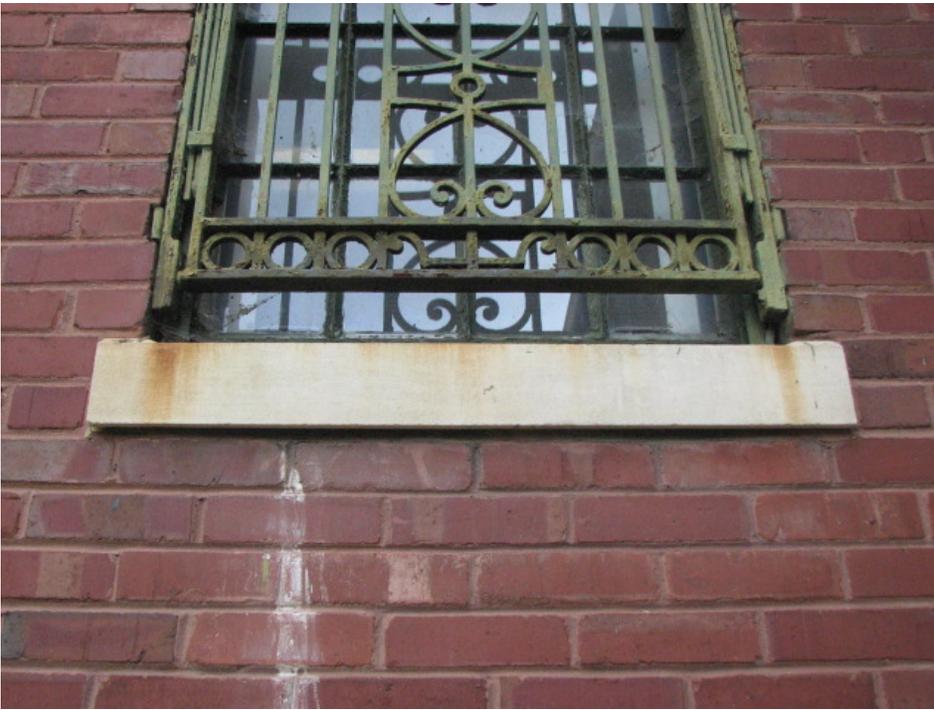
Photograph Number 18

Window grating
